# NDT Incident

## Incident details

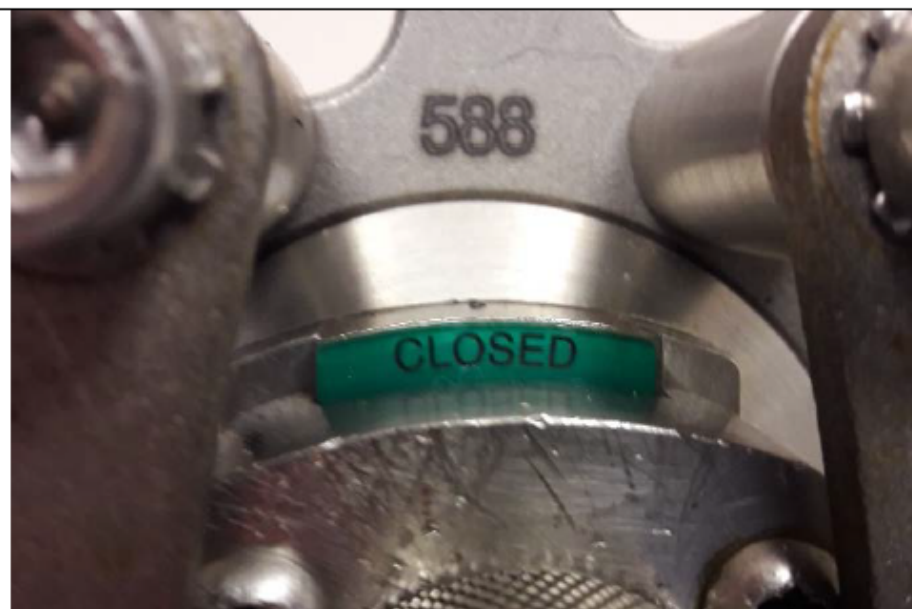
### SAFE TO APPROCH

**GREEN CLOSED** position indicates that Source holder is inside Container and **LOCKED** in Position

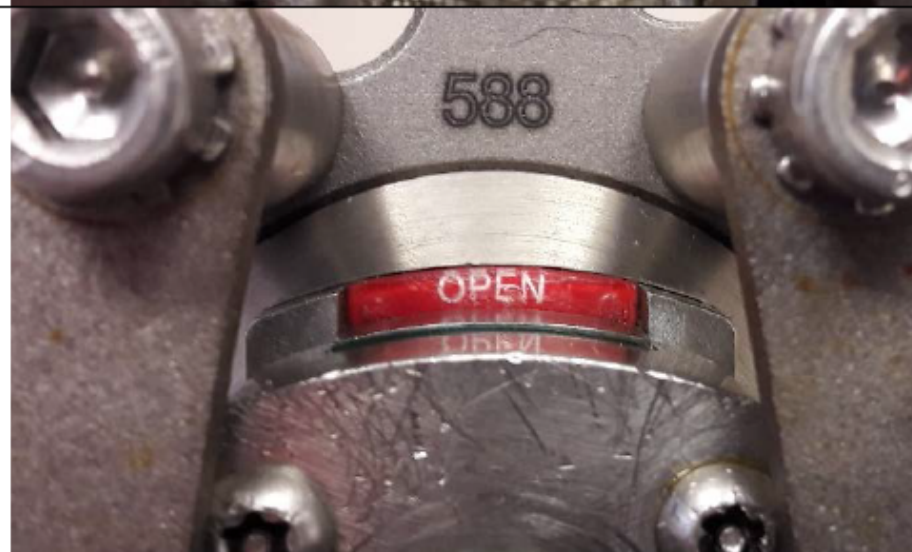
### UNSAFE TO APPROCH

**RED OPEN** position indicates that the Source holder is **NOT LOCKED** inside the Container

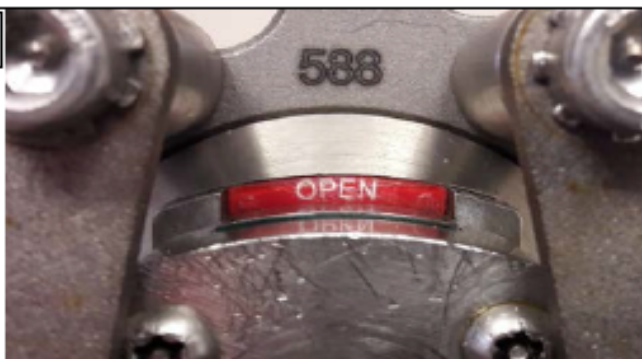
1

To disconnect the Windout Connector from the Source Holder you need to move the connector forward towards the SPS [REDACTED] unit and the connector pulled from the source holder when in the 90 deg orientation

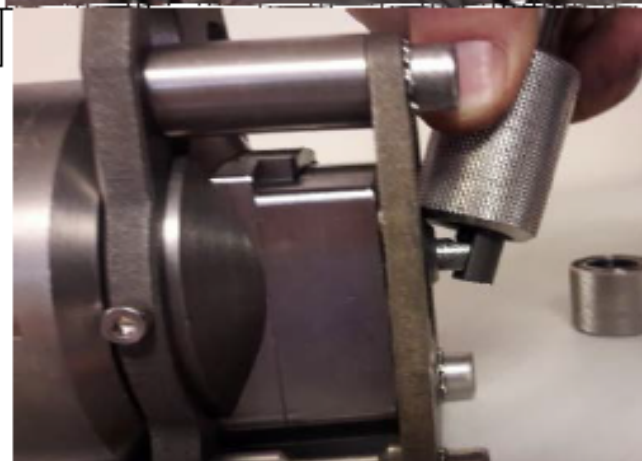
If the Lock is in the **RED OPEN** position, then 2 things are evident

1. The Lock Status Indicator is directly in front of the Operator in this position
2. The Source Holder will not be locked and therefore move freely towards the [REDACTED] unit. This prevents the Operator from being able to incline the connector to the 90 deg position for removal

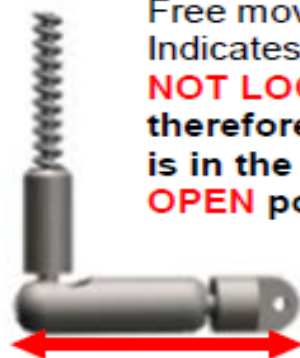
2

Free movement Indicates Source is **NOT LOCKED** and therefore the lock is in the **RED OPEN** position

**Both above should be sufficient to indicate to the Operator that it is unsafe to remove the Connector**

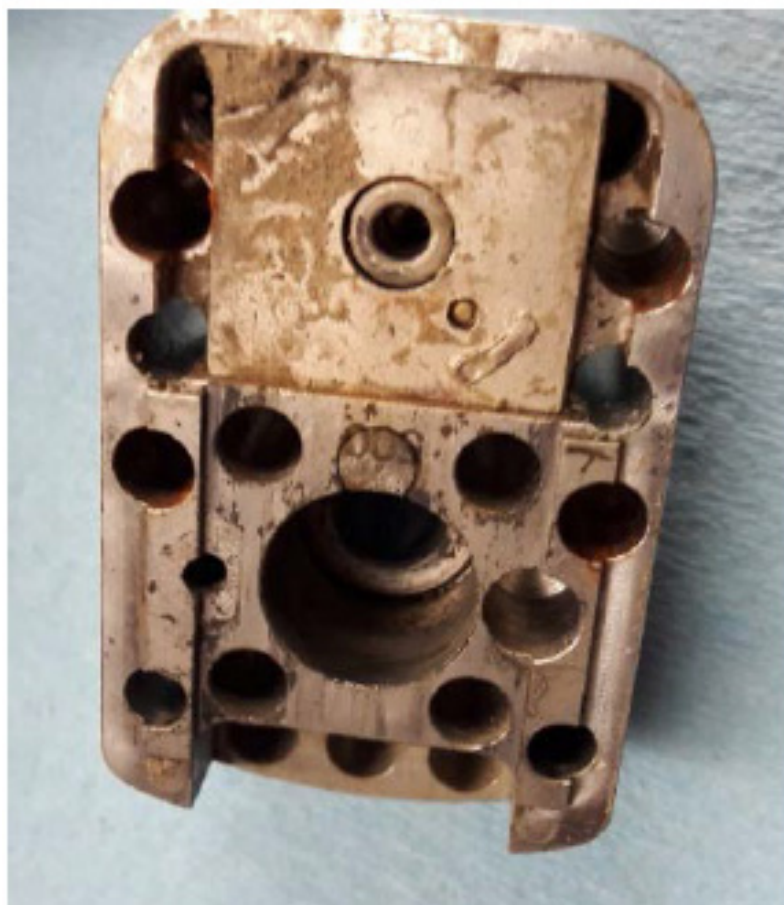
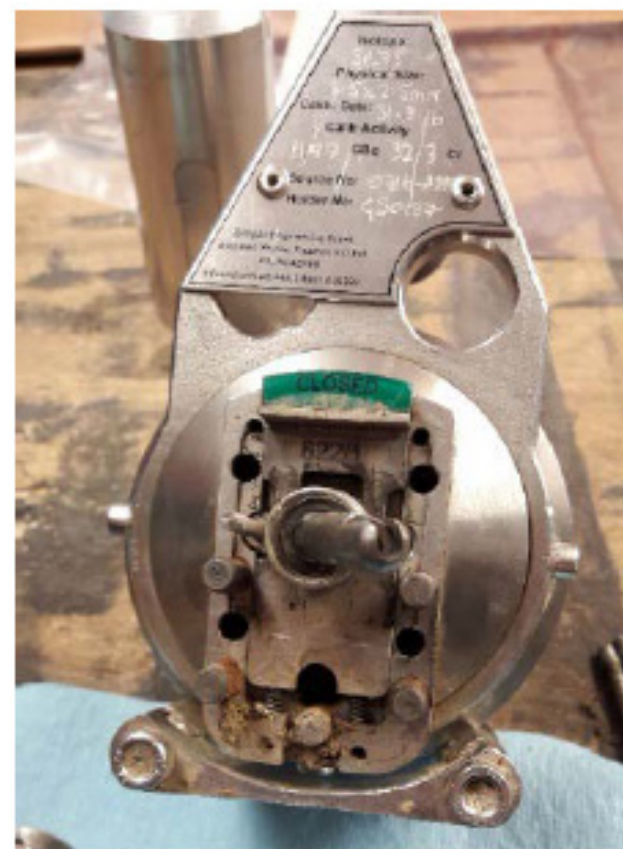
- Technical Examination of the projector took place at the Manufacturer's headquarters on Feb 6<sup>th</sup> 2017.
- Automatic locking Mechanism difficult to activate
  - Bend in Inner drive cable of the wind out assembly
  - Ingress of dirt into the locking mechanism of the unit
- Locking mechanism worked perfectly why stripped down cleaned and lubricated
- The Manufacturer Concluded:
  - Ingress of dirt caused the ALM to malfunction
  - If SOP followed for disconnection then it should not have been possible for the source assembly to have fallen on the ground.

The automatic locking mechanism on the projector was failing due to most likely the excess of dirt that had accumulated within the locking mechanism. This dirt would have caused an increase in friction that could not be overcome by the wind-out.

The safety features of the Projector are susceptible to the ingress of dirt and soil which may prevent them from performing their intended function.

- As demonstrated by this incident the Projectors can be used in different and disparate environments which can result in the ingress of dirt and soil and thereby may compromise the safety features of the unit, in particular the automatic locking mechanism.
- The manufacturer is to review their maintenance programmes for the Projector and determine what additional measures can be taken by the operators or the manufacturer to minimise this occurrence and implement them.
