Département fédéral de l'intérieur DFI  
**Office fédéral de la santé publique OFSP**  
Unité de direction Protection des consommateurs

# Ra-226 in waste disposal sites and radium action plan in Switzerland

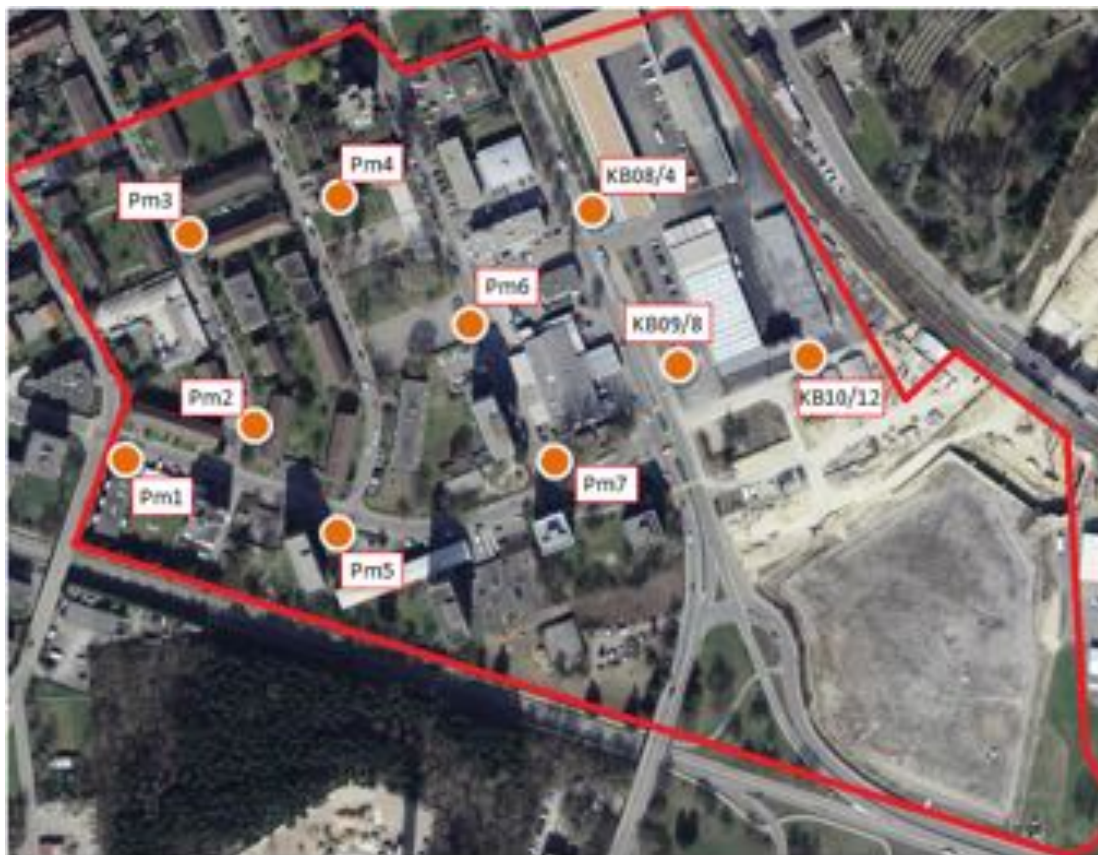
# Sampling sites for percolation water

- Ra-226 concentrations in percolation water have been measured on 10 sites (depth: 2 to 5 m, measurements IRA Lausanne)
  - On 6 sites the radium values are identical to those known for natural groundwater.
  - On 3 sites the values were between 37 and 43 mBq/L
  - On 1 site 173 mBq/L have been measured → clear indicator for the presence of artificial Ra-226
  - All values are below the EU limit value of 500 mBq/L Ra-226 in drinking water. The city of Bienne does not extract groundwater for human consumption in the area of the former disposal site.
